Bridge Inspection Report

026-38-03430 A
SR 26
over
SALAMONIE RIVER

FRACTURE CRITICAL INSPECTION REPORT

Bridge No. 026-38-03430 A, a seven (7) panel Pratt through truss, carries SR 26 over the Salamonie River in Jay County, Indiana at RP 141+23. The bridge was built in 1941 and is identified as a Historic Non-Select bridge. The bridge was repaired in 1979 with a new deck and some structural repairs. The structure length is 154.7 feet long with a maximum span of 150 feet. The bridge has a clear roadway width of 28 feet accommodating two lanes of traffic and an out to out width of 29 feet. The bridge is currently load rated for 20 tons. The average daily traffic (ADT) in 2014 was estimated at 2541 vehicles per day.

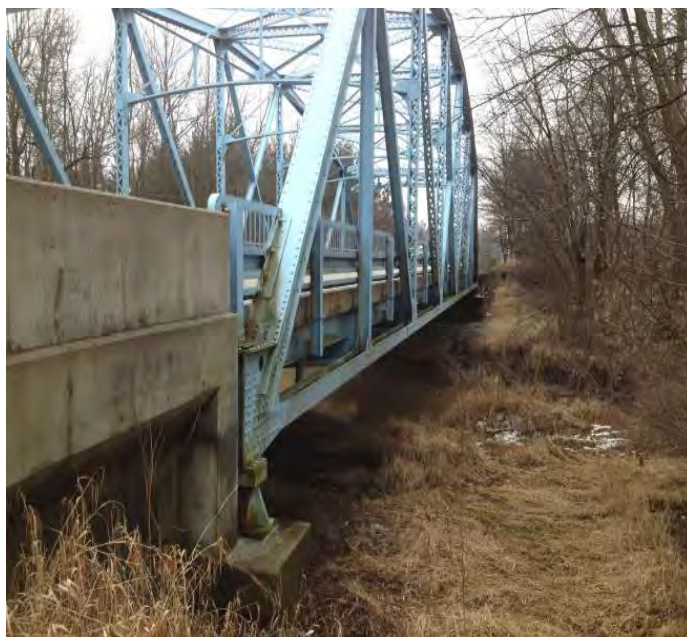
PHOTO 2 Description 011 - Looking SW at N elevation - 26-38-03430A Salamonie River NBI 007040 01-21-2015.JPG

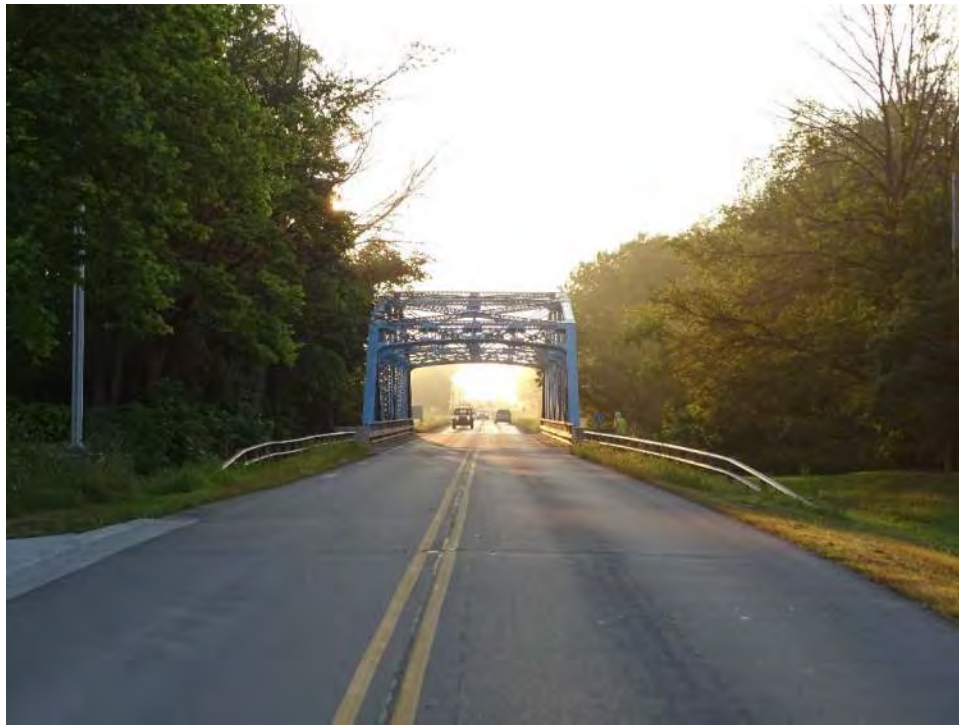
Photo 1: West Approach Looking East

West Approach: grooves from milling machine on surface at west end; chipping along 1A joint; wide, irregular crack along center line, with spall near 1A joint; spall on curb in SE corner;

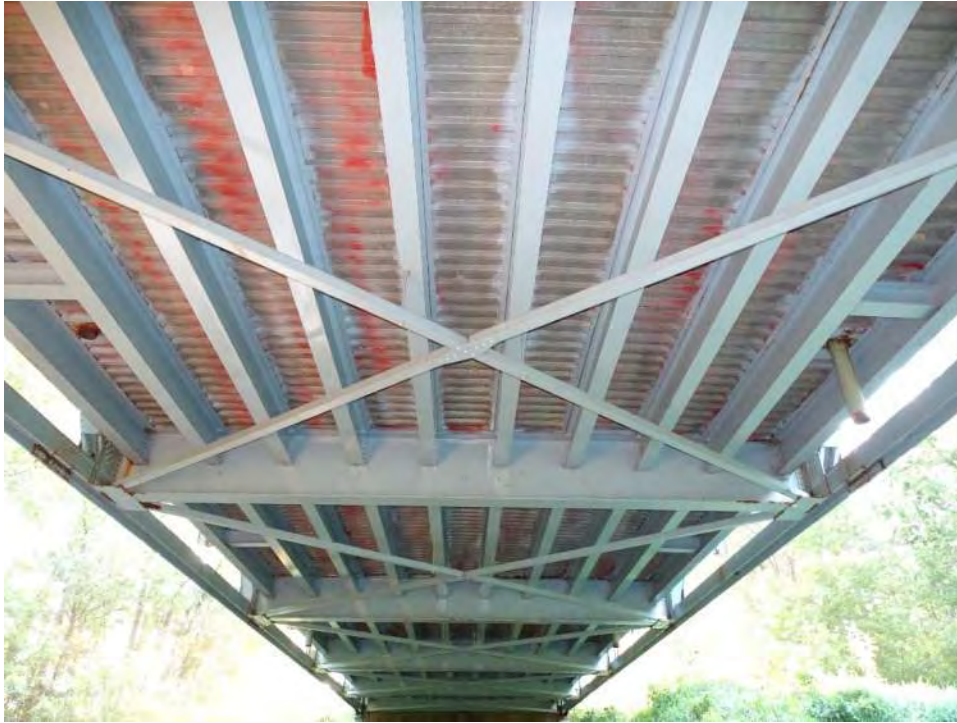
Photo 7: Floor System

Section loss to flanges & webs of outside stringers in the end panels - esp. heavy @ corners - bottom flange SW has a 1" wide area of section loss - remaining steel tapers down to paper thin @ edge; holes thru webs of outside stringers @ corners: 3"x3"- SW & 1"x10"- SE; minor pitting & section loss to N. stringer in bay #2 from the East; Stringer #2 from the north on E. side of floor beam #4 - top flange damaged/torn down @ coped area (~2" tear).

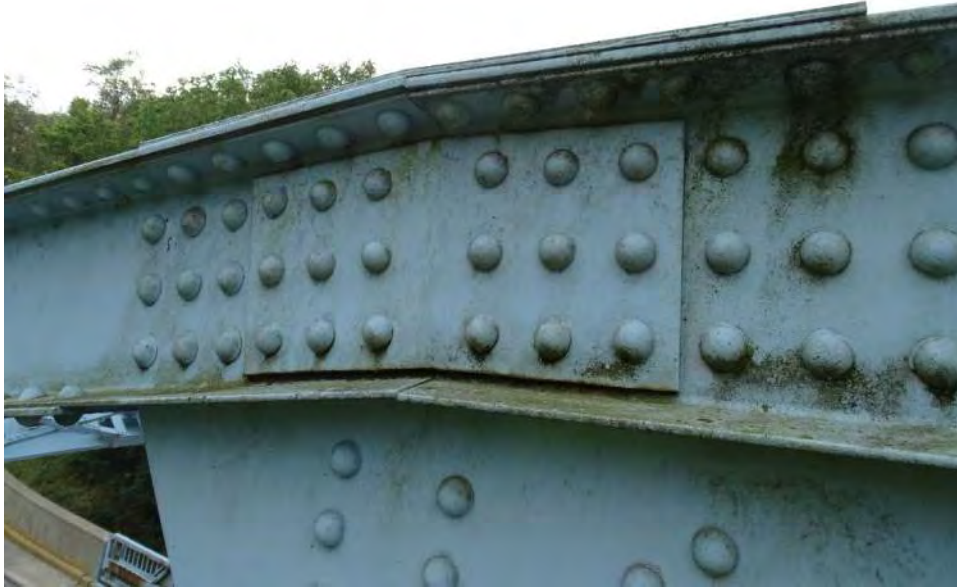
Photo 41: Upper Chord Connection (Typ.)

All other Upper Chord Members looked to be in good condition, from the deck.
